Global Stability Analysis Saves the Day in Boulder, Colorado

The Ridge at Broomfield is a 15-acre, new multi-family development located in Broomfield, CO – just outside of Boulder. Broomfield has recently experienced a multi-family boom and when completed, the project will include 292 rental units in the sought-after neighborhood. The reasons for the boom are plentiful and include easy access to I-36, proximity to public transit, recreation, employment and downtown Boulder. With one, two and three-bedroom rental properties, The Ridge at Broomfield will provide many individuals and families with a fun environment and a great home for years to come.

Name: The Ridge at Broomfield

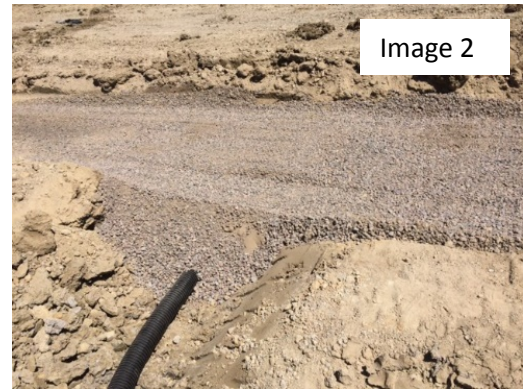
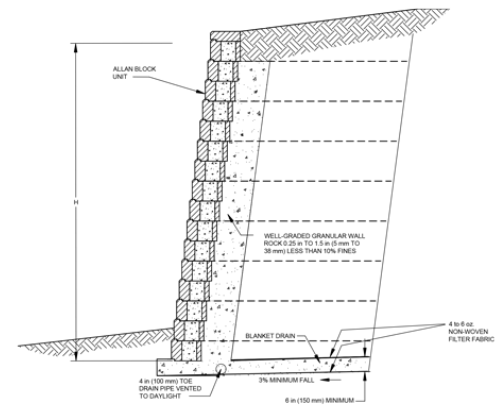
BLANKET DRAIN DETAIL
Shall be used in locations within Wall #1 in which the geotechnical engineer of record determines that groundwater is present, and has the potential to infiltrate the goegrid reinforced zone from below.

As seen in Details 1-4, the flexibility of the Allan Block system and [AB Walls 15 Design Software](#) allowed SK Design to use their expertise to efficiently create a design tailored to The Ridge at Broomfield. Detail 1 and 2 show water management practices such as blanket and chimney drains to help remove water from behind and below the application.

The blanket drain used to help remove water also incorporated a french drain as seen in Image 1. French drains are common solutions when water is present within the base. The chimney drain was a manufactured drainboard to help remove water from behind the structure as seen in Detail 2. Both the blanket and chimney features were incorporated to help reduce the likelihood of hydrostatic pressure building within the reinforcement zone. Detail 3 and 4 will provide a visual of what may happen when global stability is a concern. Instead of grid depths in line with Best Practices, walls on The Ridge at Broomfield site saw grid extended to 200-300% of wall height in worst case scenarios. You will also notice the additional depth needed to compensate for the toe slope in Detail 4. For a 12 ft (3.6 m) tall wall there is over 2.5 ft (0.75 m) of block buried which is much more than typical Best Practices standards previously discussed. Steve Kelley with SK Design was excited about the opportunity to design such a project and recently shared with us *“the design challenged me to use a variety of details and*

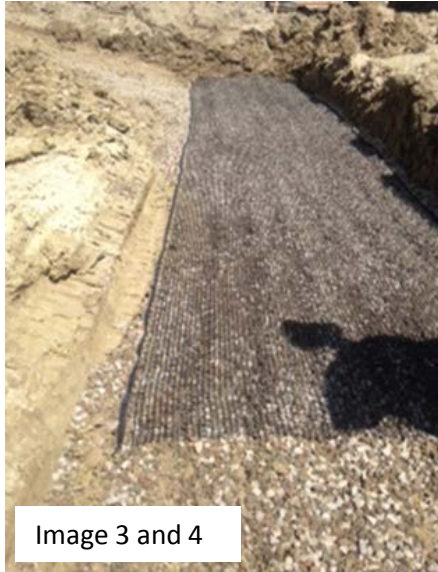
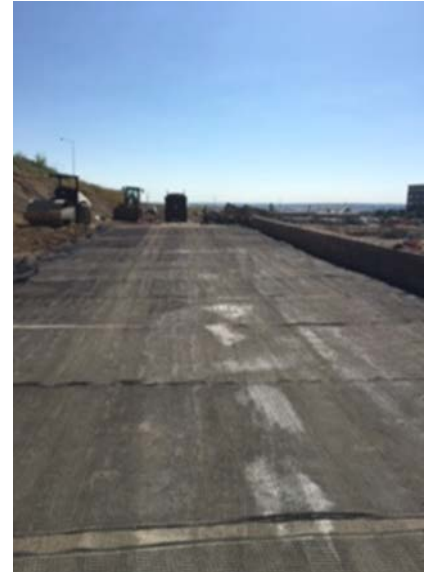
Image 3 and 4

[Slaton Bros.](#), of Denver CO, (has several [Allan Block Master Wall Builders](#) on staff) were retained as the wall installer. Their experience, training and attention to detail was imperative to the long-term success of the project due to the various site challenges previously outlined. This design was unlike most they see and during construction they had to pay close attention to the design details. In addition to the french drains outlined above, they also had to install reinforcement within the

retaining wall foundation for added stability (Image 3). Their expertise was put on display when installing the manufactured chimney drain as well. Since they could not cut vertically due to the wall height and OSHA requirements, the chimney drain had to be installed on a 45-degree angle and precisely done to allow for collection of water from behind the reinforced mass. Slaton's performance was superb, and the meticulous details outlined within the design were easily incorporated within the Allan Block structure to overcome the hazards of this treacherous site.
