**Project Summary**

# State Route 14

### **Upgrading a Major Freeway**

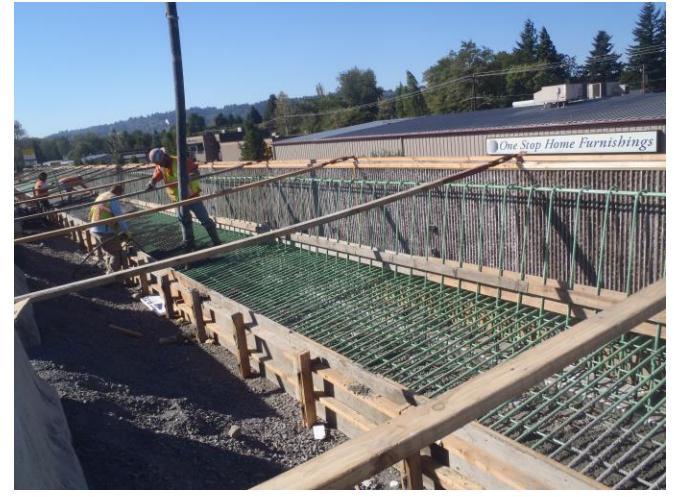
Multiple design options were considered and presented to WSDOT for the facing side and

the reinforced side of the drop structure. The first was to have the drop structure built as a rigid structure to transfer the facing loads back to the reinforced mass. The proposal was for the Allan Block facing to be physically attached to the side of the drop structure by using concrete anchors and casting the Allan Block cores solid, capturing the anchors. On the grid side, a common wall attachment technique was suggested and that was to attach horizontal spreader bars, using embedded anchors, to the side of the drop structure and have the geogrid layers wrapped around them to form a continuous attachment.

The second proposal considered a variation of the attachment on the mass side. By using a geogrid wrapped wall design up against the side of the drop structure, the spreader bar and anchors could be eliminated. After much review, WSDOT rejected both proposals because in the end, they decided that an option where neither the wall nor the grid was attached to the drop structure would be best for them.

The final solution then was to use the geogrid wrapped wall design with the interrupted grid layers on the mass side of the structure. On the facing side, WSDOT and FEI agreed to utilize the hollow core of the Allan Block units by constructing a fully reinforced wall with both horizontal and vertical reinforcement. The vertical reinforcement would be tied directly into the moment slab structure above forming a continuous structural connection. This application extended a few feet to either side of the drop structure and fully satisfied WSDOT's requirements.

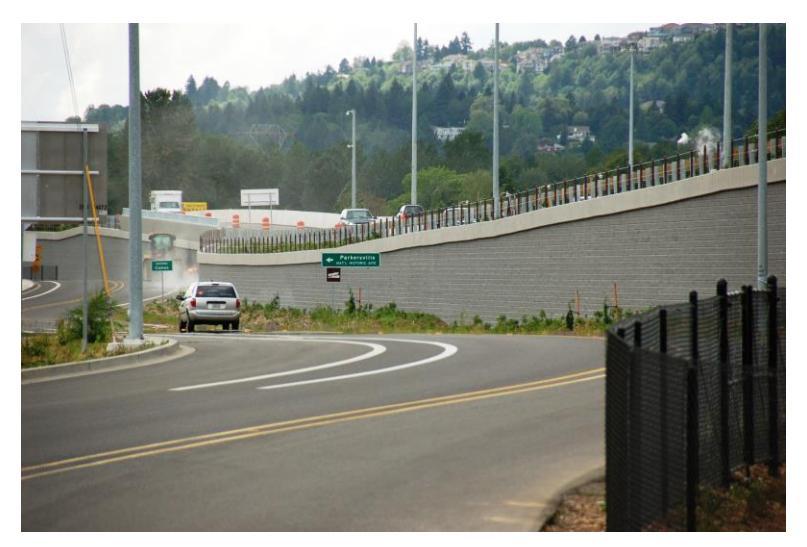
The project required a high level of detail and accuracy in both the design as well as in the plans for construction. The wall needed to be carefully designed and laid out so that it lined up properly with the bridge abutments for the project and also fit within the property easements while still allowing room for construction activities. FEI Testing and Inspection used the .dxf output feature from the AB Walls design software to precisely align the wall to the required project stationing and offsets. They also

labeled every step up and step down location for the project so that the precise wall positioning could be achieved and the locations could be matched to the bridge abutment positions.

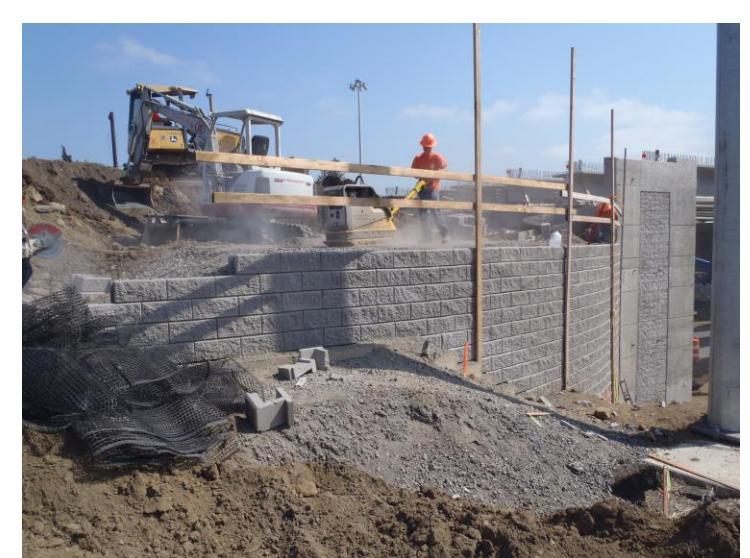
Other items that were closely monitored during the construction phase were the soil compaction, soil testing, and wall alignments. Proper soil compaction is a critical element to a properly constructed wall. WSDOT had a closely supervised compaction testing schedule for all of the walls. This ensured that the structural fill used on the project was properly placed and that it met with the design requirements for a project in a seismically active region. Additionally, site surveyors worked closely with FEI and Tapani Underground to carefully

monitor and control the wall alignment during construction. Careful layout and close attention to proper leveling techniques ensured that the walls properly aligned with the bridge abutments when all was said and done.
